WAIKATO RIVER

Hazard Assessments, Behaviours, and Factors that may Encourage Risky Behaviours.

April 2023

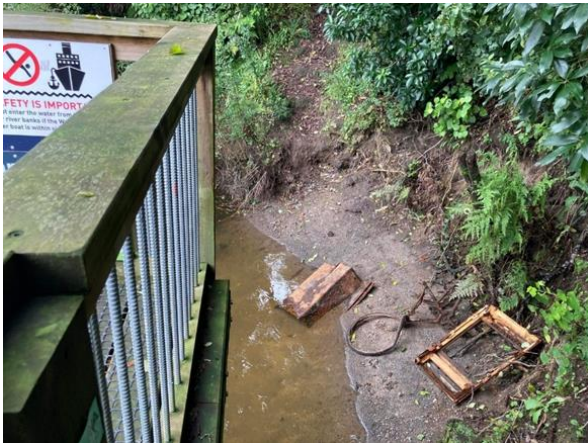
Figure 3. Hamilton Gardens - Examples of debris

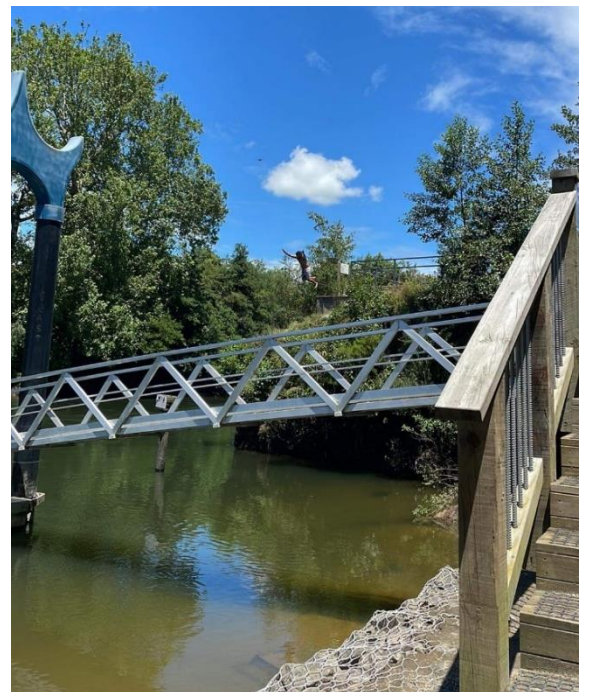
Figure 4. Hamilton Gardens - River user jumping from height

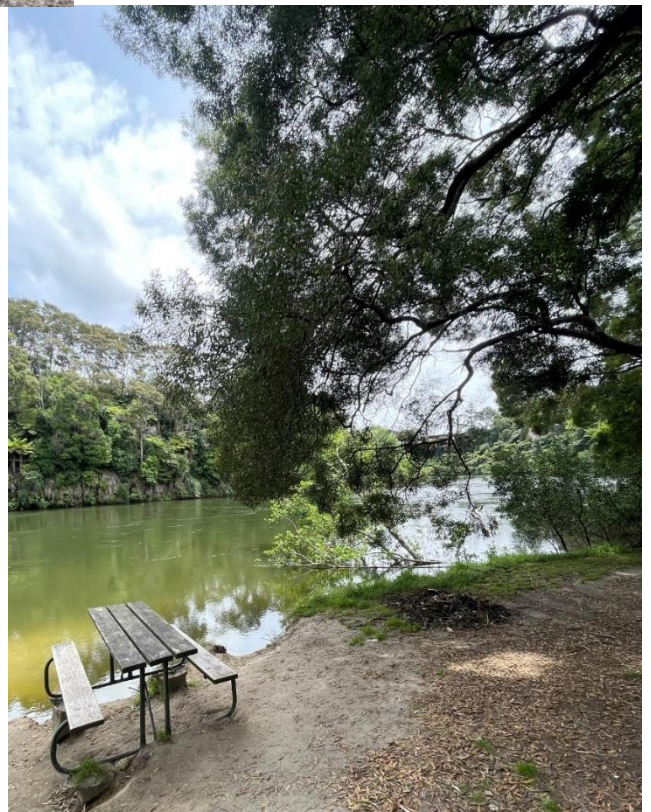
Figure 6. Hammond Park Beach - Western view of site showing strainers and jump spot from tree

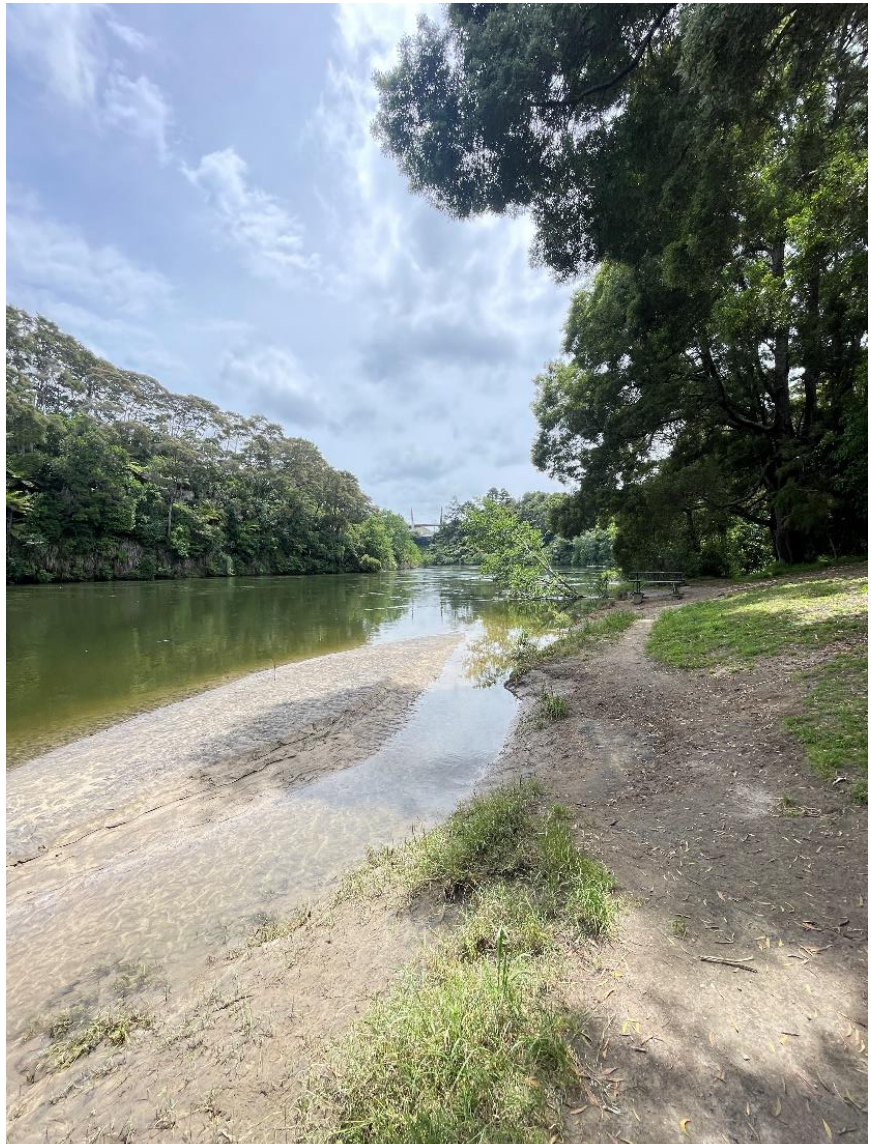
Figure 7. Hammond Park Beach - Sandbars before the strainers and jumping tree

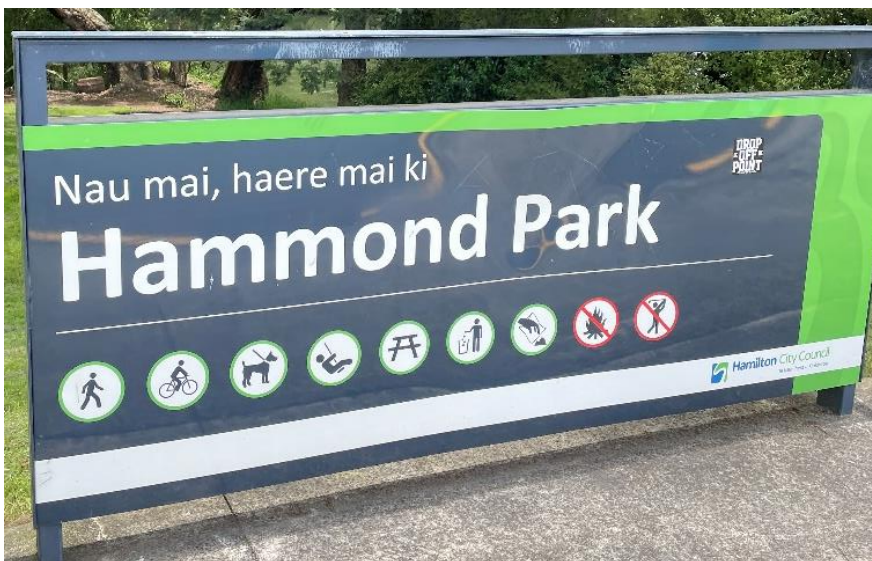
Figure 8. Hammond Park Beach - Existing signage at roadside

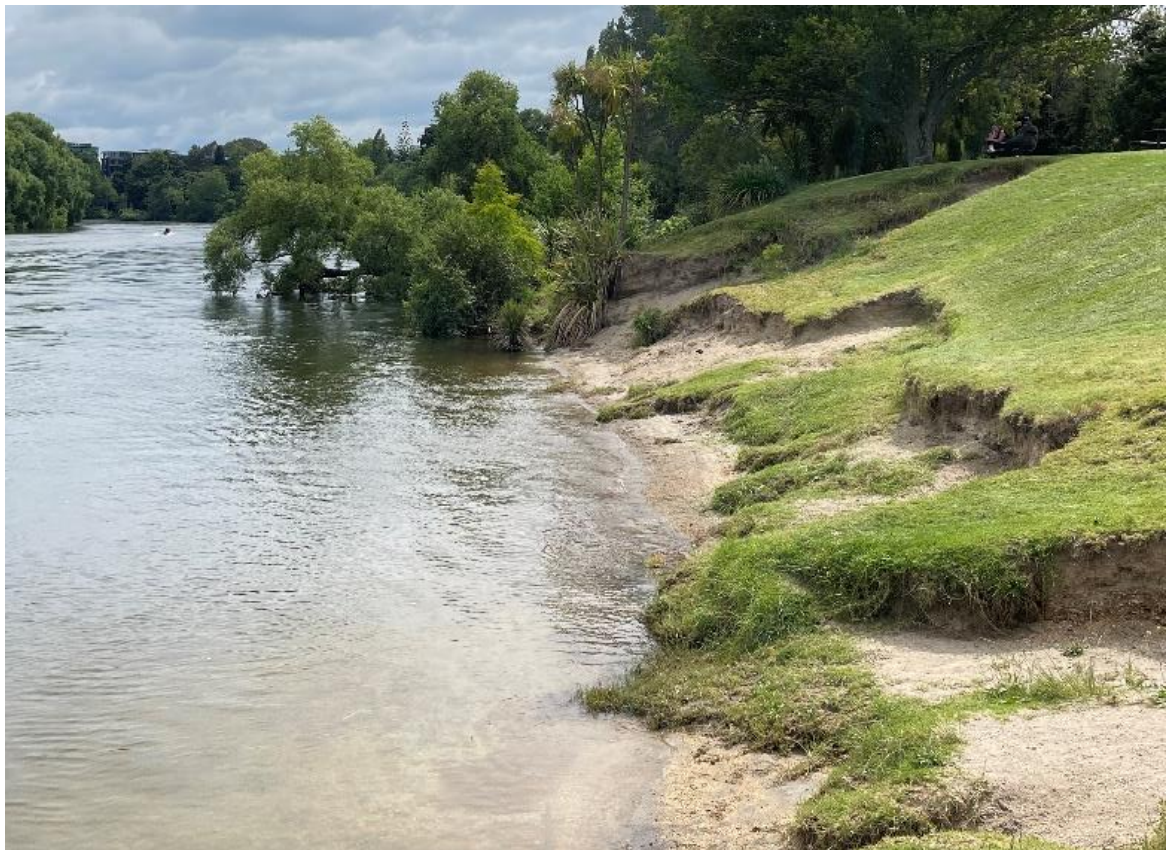
Figure 9. Wellington Street Beach - Unstable banks and vegetation downstream from jetty

1. Infrastructure
 - a) Repairs to the jetty should be made to ensure safety of users.
 - b) Address erosion issues with the unstable bank.
 - c) Consider a swinging jetty to allow the steps to be usable in both high- and low-flow.
 - d) The installation of a fixed water depth gauge.
2. Signage
 - a) The following warning symbols are recommended to be included on a compliant, new aquatic hazard sign:
 - Unstable banks
 - Strong current
 - Sandbars

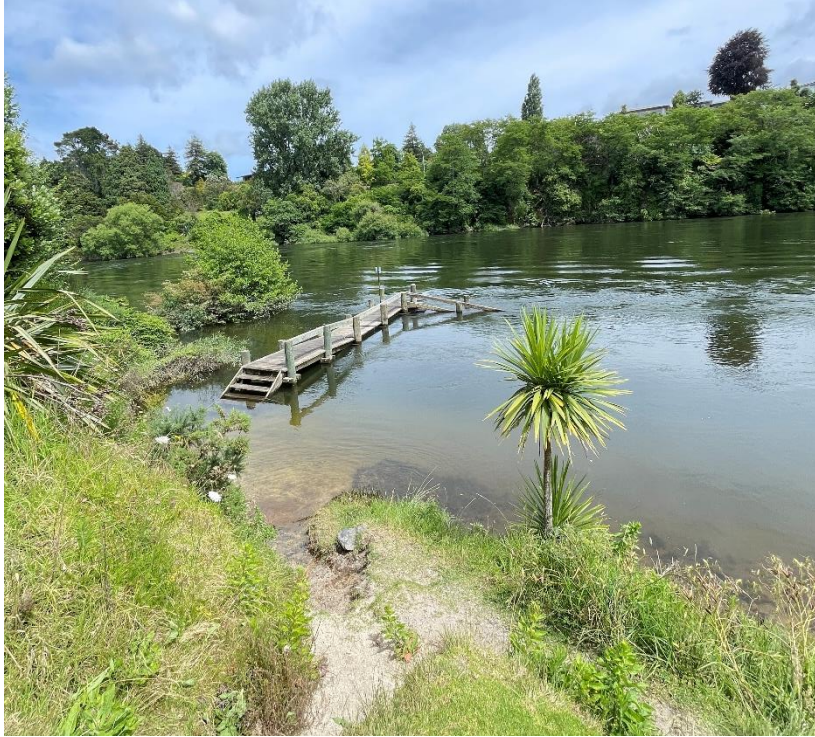
Figure 10. Wellington Street Beach - Debris to east of jetty and sudden drop off

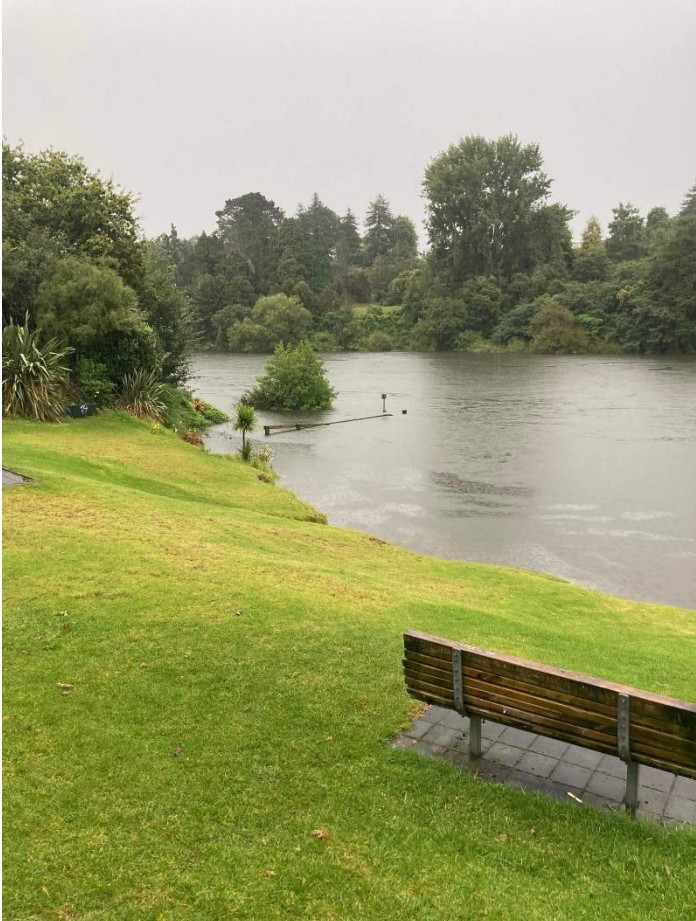
Figure 11. Wellington Street Beach - Submerged jetty during flooding

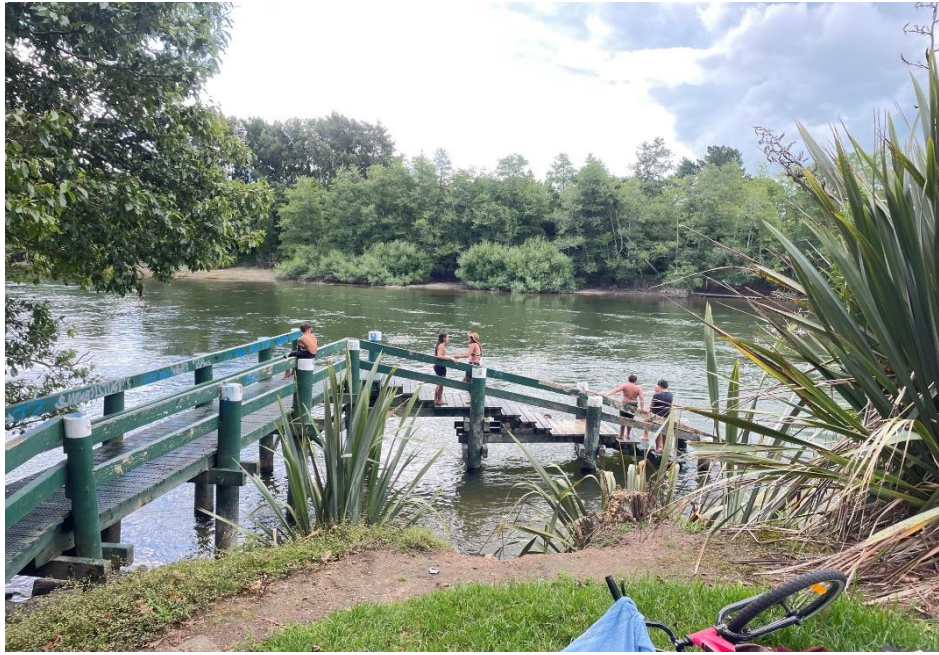
Figure 12. Swarbrick Landing - View of the access / egress during low flow

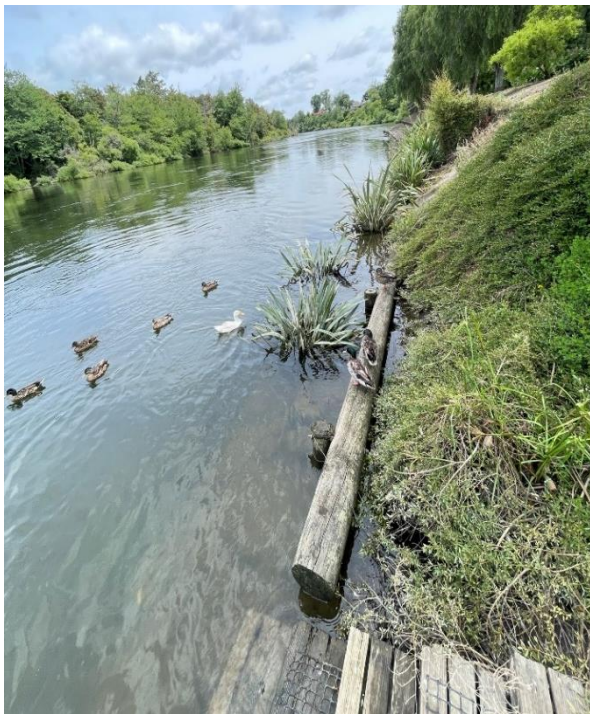
Figure 14. Swarbrick Landing - Jetty during high flow showing difficult egress points if stairs are missed

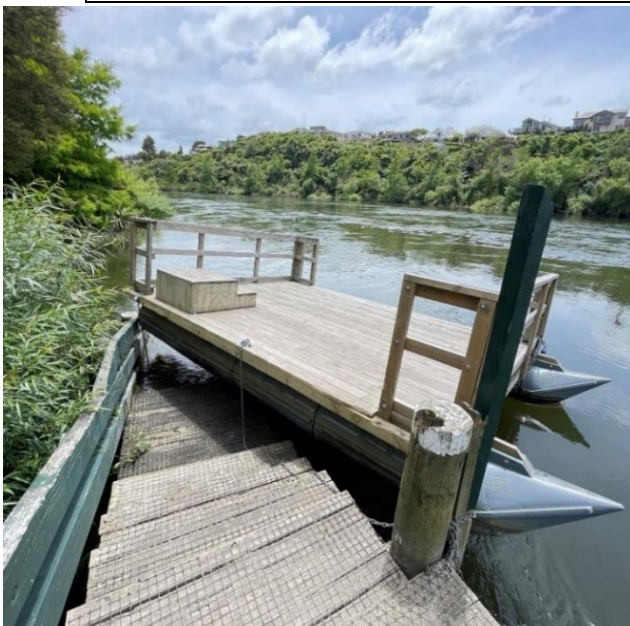
Figure 16. Braithwaite Jetty - Displaced pontoon jetty

1. Infrastructure
 - a) Repair the jetty for safe usage, ensuring ease of egress.
 - b) The installation of a fixed water depth gauge.
2. Signage
 - a) The following warning symbols are recommended to be included on a compliant, new aquatic hazard sign:
 - Fast flowing current
 - Sudden drop off
 - Entanglement risk
 - Submerged objects
 - Reduced buoyancy in freshwater
 - Supervise children at all times

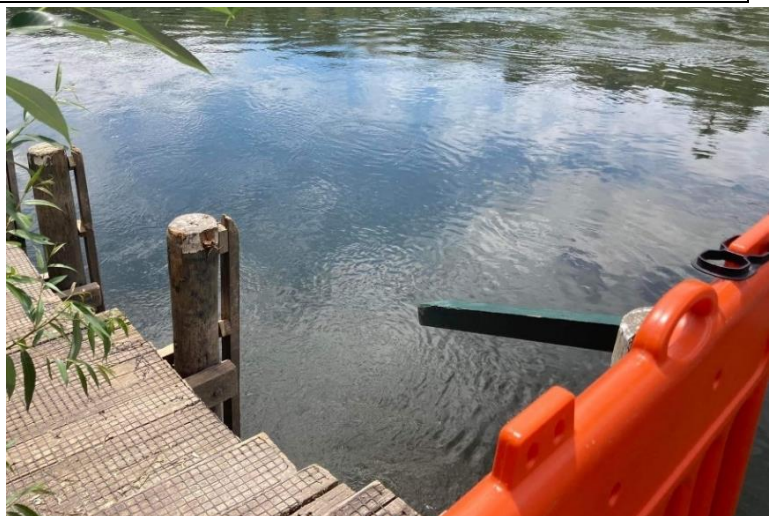
Figure 15. Braithwaite Jetty - Closed site and damage to support beams

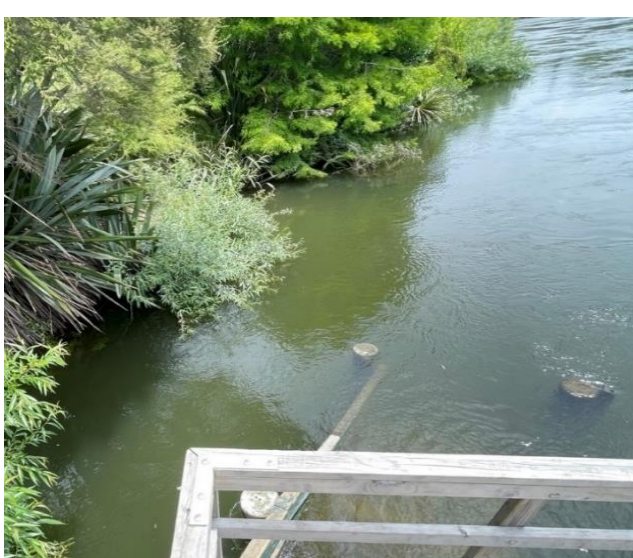
Figure 17. Braithwaite Jetty - Entrapment risk underneath pontoon

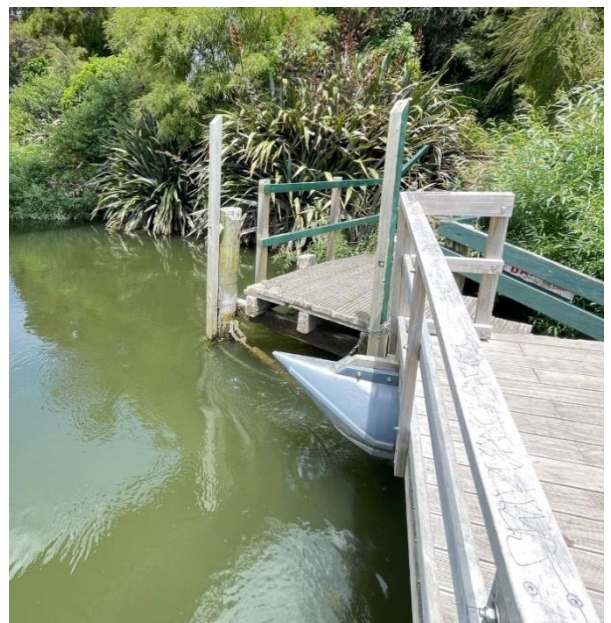
Figure 18. Braithwaite Jetty - Pontoon during high flow

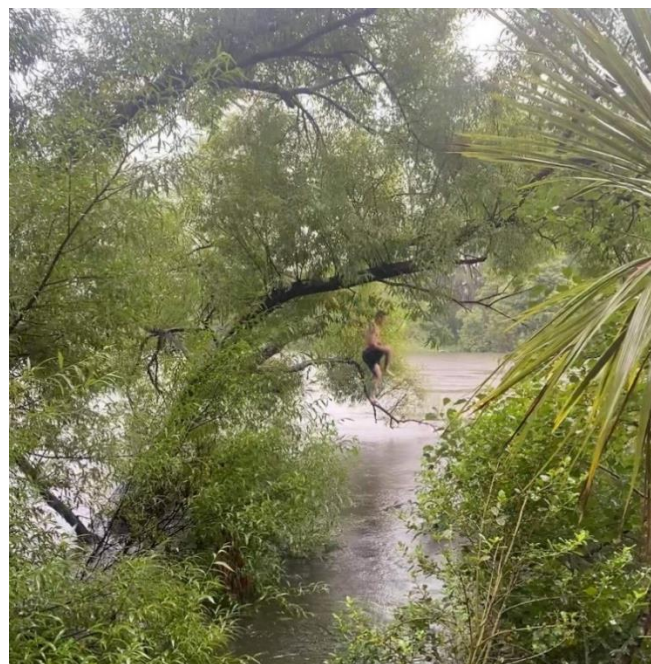
Figure 19. Swarbrick Landing - Tree jumping during high flow into murky water with unknown depth

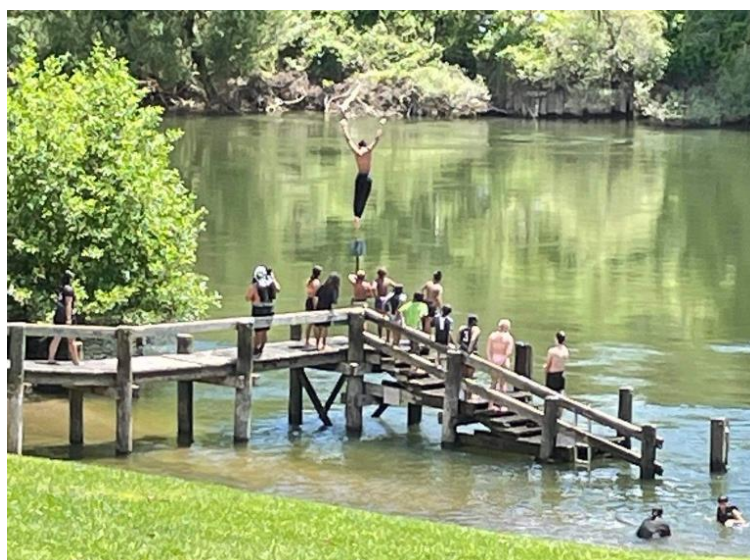
Figure 20. Wellington Street Beach - Unsafe behaviours of river users

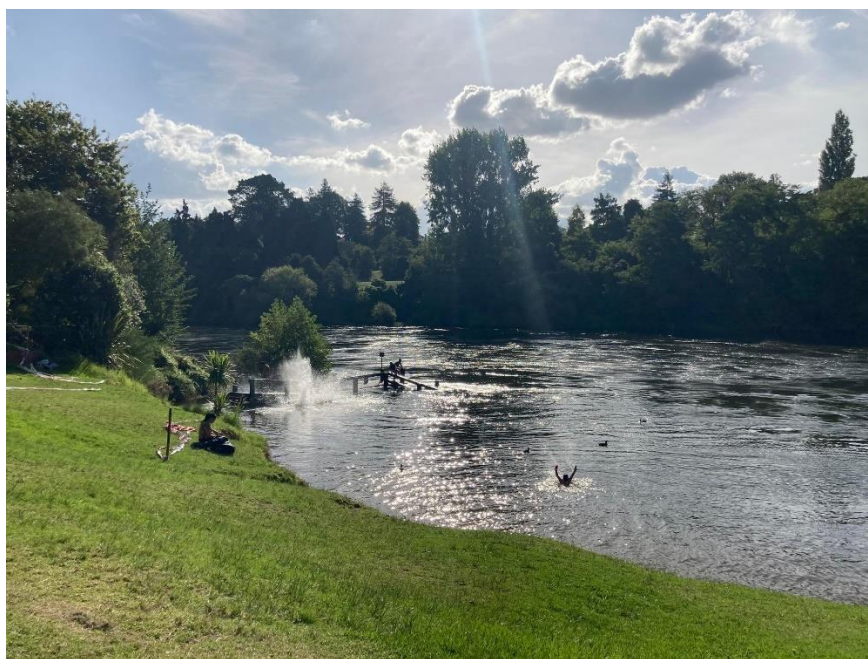
Figure 26. Hamilton Gardens - Jetty Under Water During High Flow

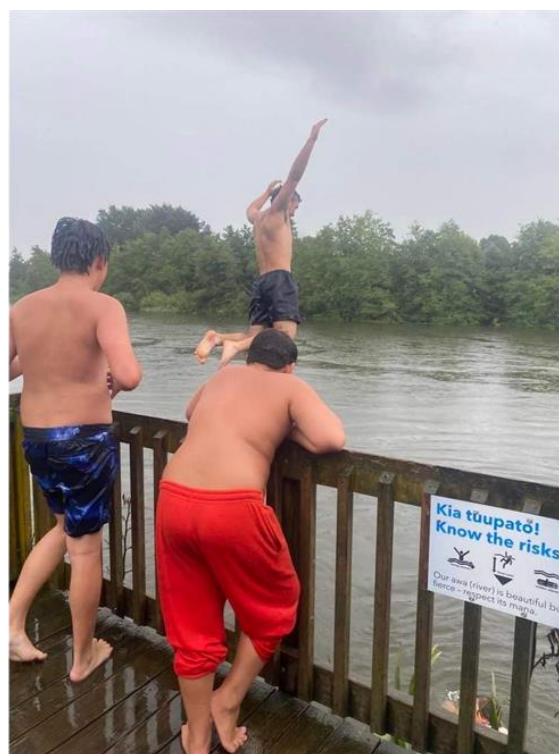
In times of high flow, members of the public have been observed to jump off the railing of the viewing platform into shallow water. At times of low flow, exposed rocks and sand are below this viewing platform can be seen, which members of the public may not be aware of when jumping at times of high flow. This is cause for great concern as serious harm or injury may occur from this.

Figure 27. Swarbrick Landing - Jumping from Viewing Platform - Shallow Water with Obstructed Entry

2. Signage
 - a) The following warning symbols are recommended to be included on a compliant, new aquatic hazard sign:
 - Submerged objects
 - No jumping/diving
