CASE STUDY:

Has New Zealand Search and Rescue improved since the 1994, Pacific Storm event, in the South Pacific?

Author: Dave Greenberg, October 2019

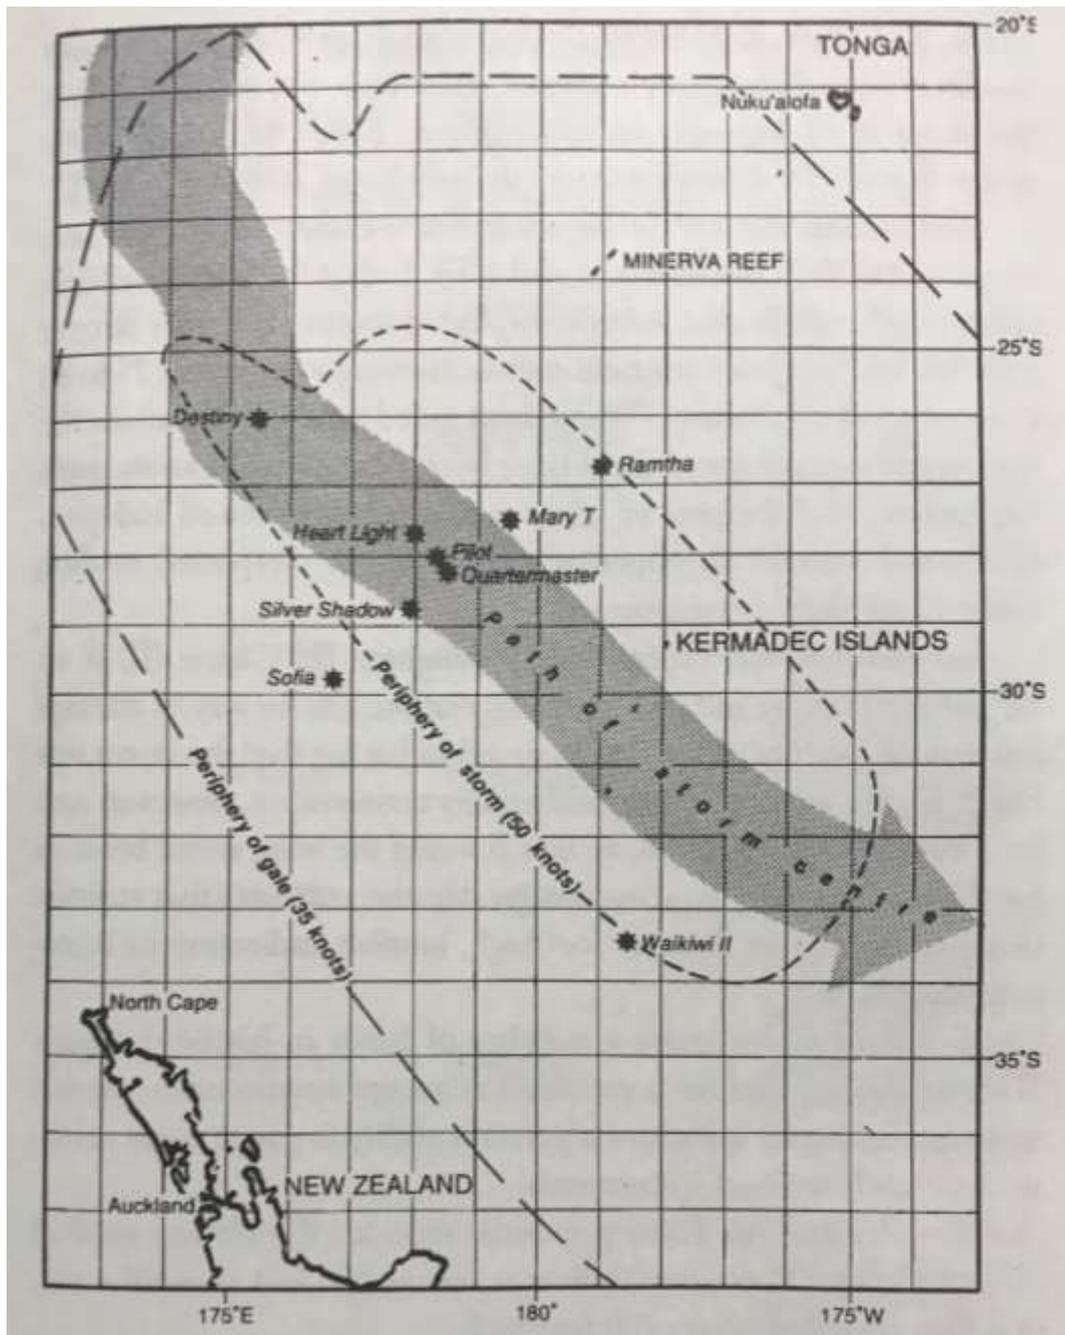
From Farrington, 1998, pg xv

Approximate positions of *Destiny*, *Sofia*, *Silver Shadow*, *Heart Light*, *Pilot*, *Ramtha* and *Waikiwi II* when rescued. Position of *Mary T* upon issuing Pan call. Last known position of *Quartermaster*.)

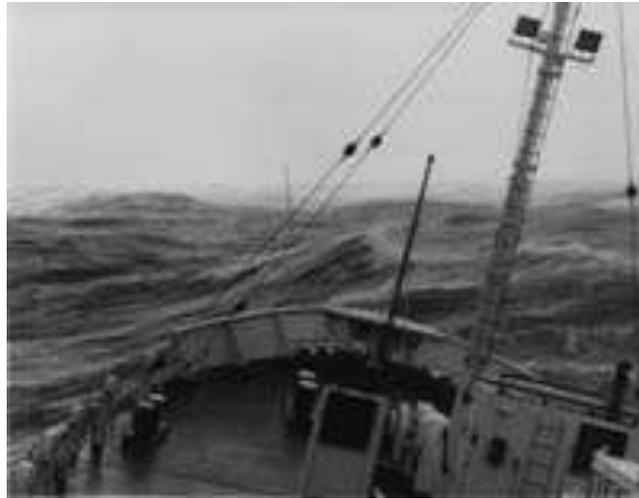
HMNZS MONOWAI approaches the disabled catamaran Ramtha in 60 knot winds and 10m seas.

From the Captain of the HMNZS Monowai (Robbins, 1999): “It was readily apparent that there was absolutely no possibility of bringing Monowai alongside Ramtha in such conditions. The traditional rescue method is for the ship to bring herself alongside the yacht upwind with cargo nets, ladders etc rigged on the lee side. The yacht’s crew would then climb nimbly up the nets to safety.”

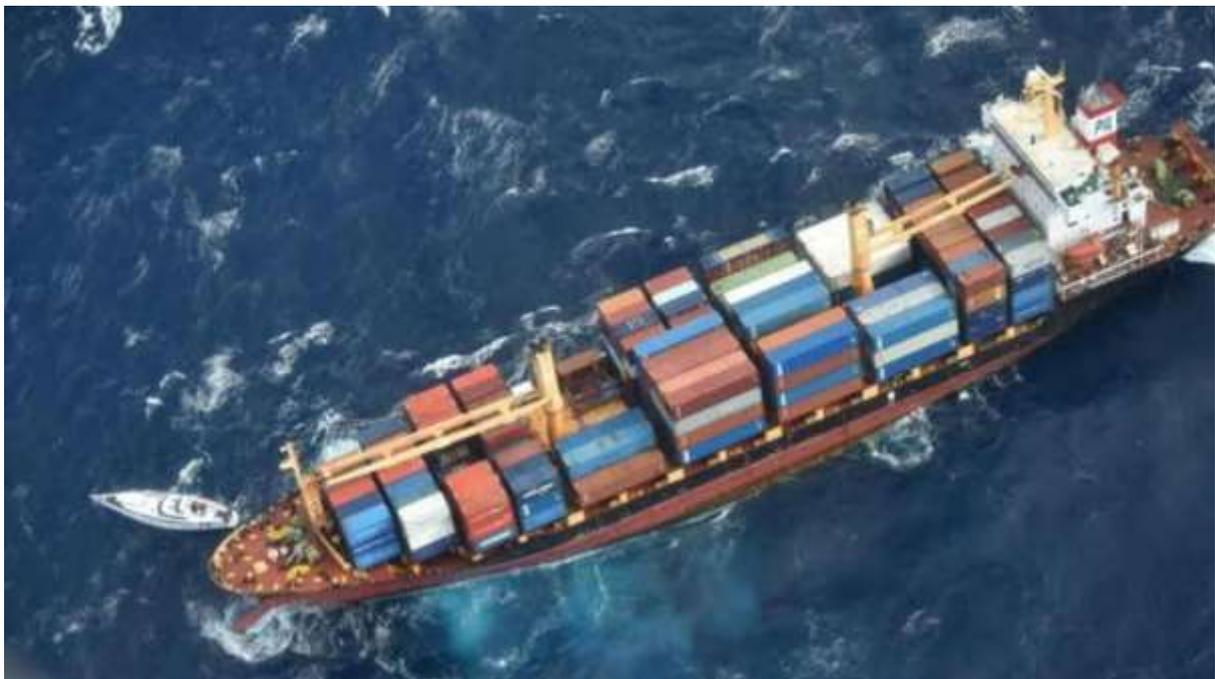
Rescue of the yacht *Platino* by the container ship *Southern Lily* in June 2016.

From Stuff (2016): Sailing from Western Samoa to Auckland, the container ship spent 14 hours battling through high seas to reach the *Platino*, its captain said by satellite phone from the ship. Captain Shashi Prakash and his 22 Indian and Filipino crew had to change their rescue plans because of persistent 3m swells and high winds."It was difficult to pick up the survivors from the small craft ... our first attempt wasn't successful... we had to use pyrotechnics to send a rope."With the rope line shot over to the *Platino*, the 20m yacht was hauled in against the 9725 tonne 145 metre container ship. The three survivors scaled a rope ladder finally reaching safety aboard the *Southern Lily*.
