INDEPENDENT SAROP REVIEW

RCC0918 / 21 / Op MYANMAR

Location: Poverty Bay

Date: 02 November 2011

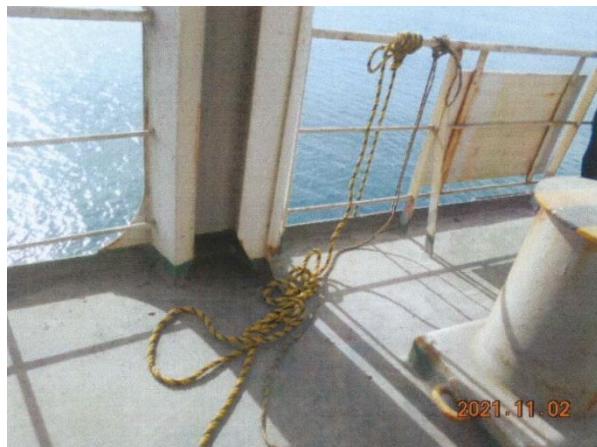
Ropes leading from the Poavosa Wisdom VII to the water

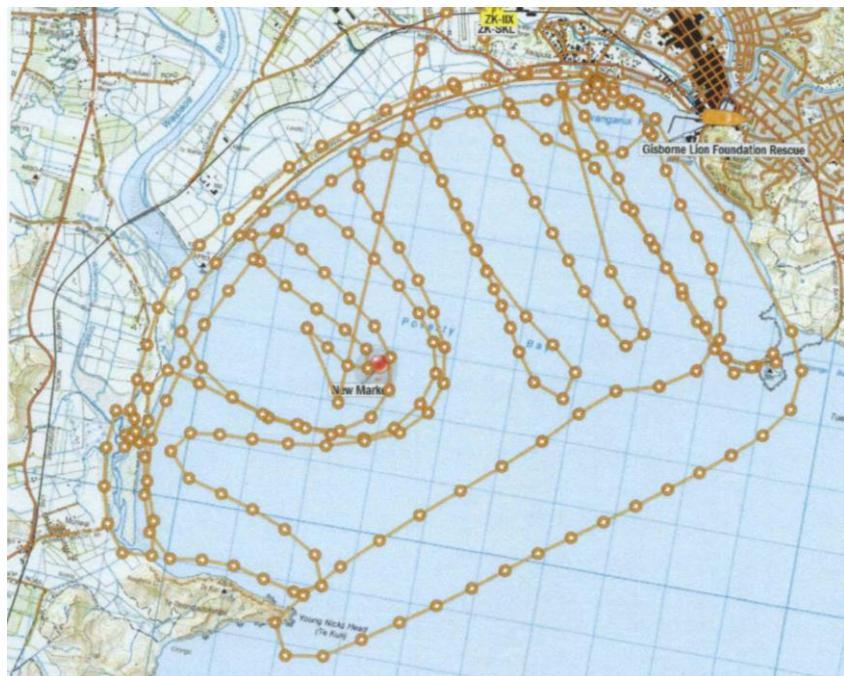
At 11.00 am, Gisborne Rescue Helicopter advised that they had not seen or found anything in their search area. They were tasked to continue searching the bay area around to Sponge Bay. At 11.08 am Coastguard launched and supported Gisborne Rescue Helicopter from the water. At 11.12 am Gisborne Rescue Helicopter was tasked to search Sponge Bay across to Te Kuri-a-Paoa / Young Nicks Head with two sweeps around beach, one slightly off-shore and one slightly on-shore, and at 11.30 am Gisborne Rescue helicopter was stood down from the search.

Gisborne Rescue Helicopter Flight track

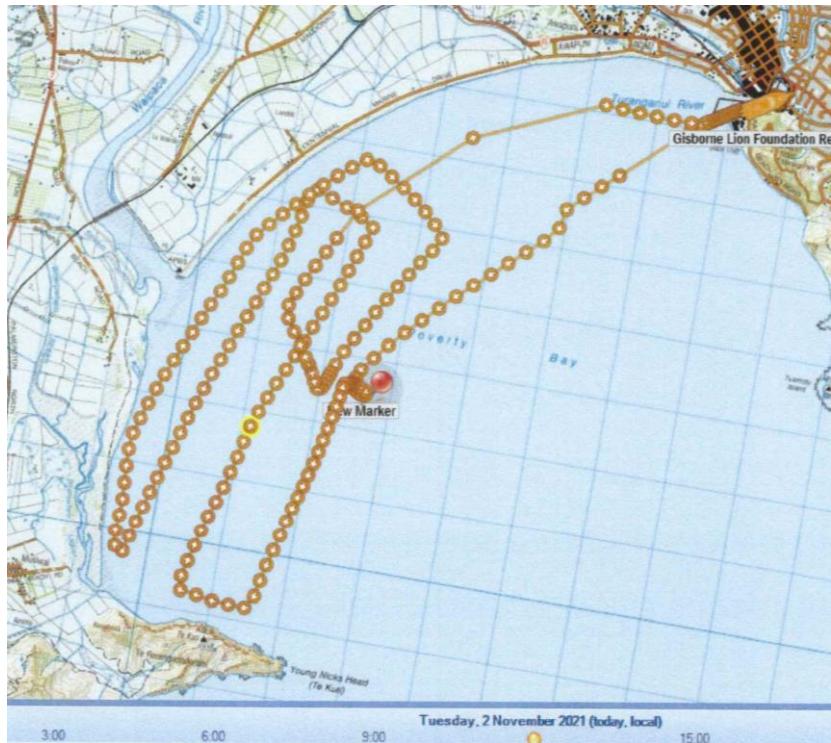
Gisborne Lion Foundation Coastguard track

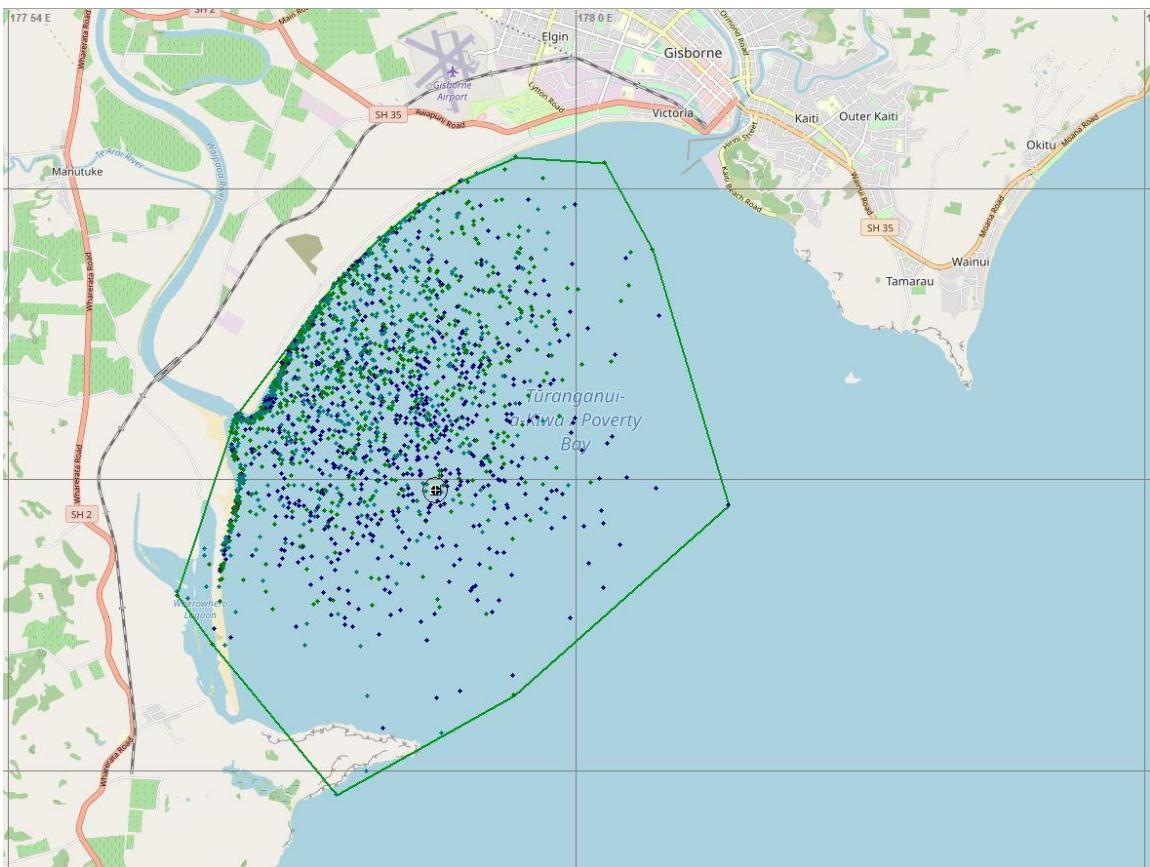
- they knew the exact boat location
- they knew he was wearing a life jacket
- they knew he was last seen at 10.30 pm the previous evening.

SAR Map drift pattern indicating high probability Search area under Low Uncertainty intel setting

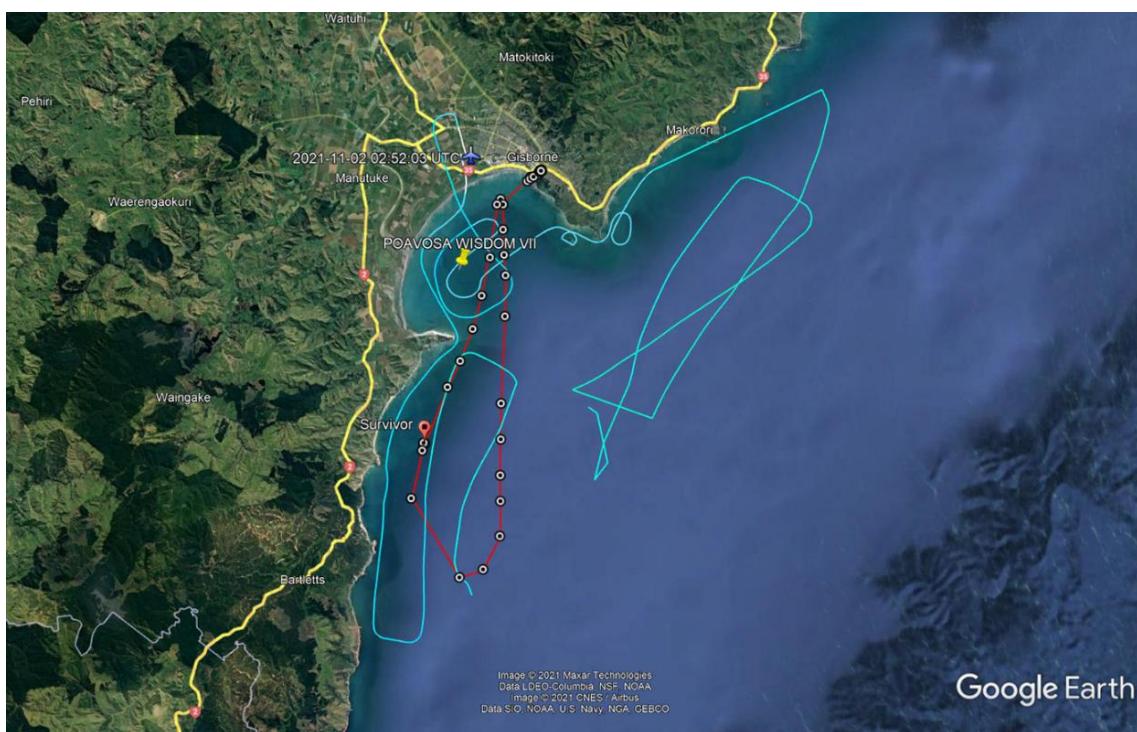
At 3.00 pm, the Eastland Port Authority self-deployed, fearing the most likely location for the crewman south of Te Kuri-a-Paoa / Young Nicks Head had not been searched, and the weather forecast was for heavy seas that evening. Initially, a privately owned fixed wing was deployed, and at 3.34 pm, Eastland Port Authority Pilot vessel RERE MOANA deployed.

Private Search PA28R Aircraft (blue) & Pilot RERE MOANA (red)

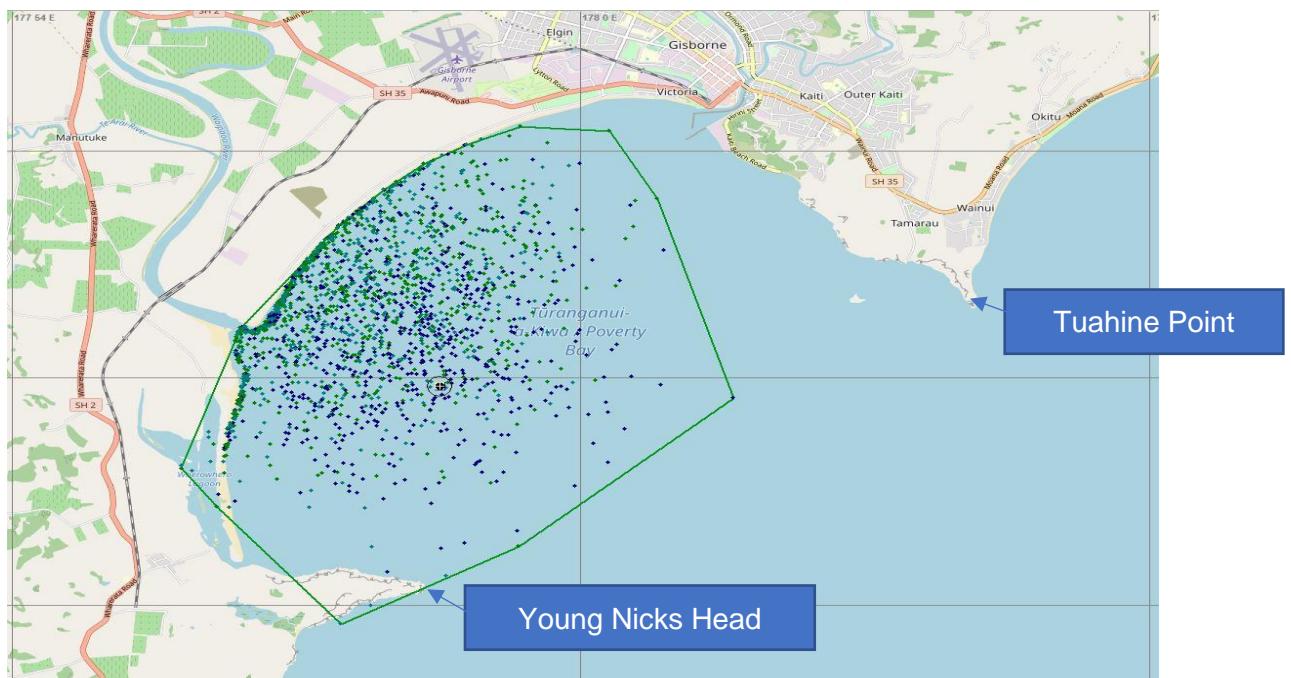
Based on the exact known location of the vessel, and that the crewman was last seen at 10.30 pm the previous evening, and the crewman was wearing a life jacket, a map was generated under *Low Uncertainty*.

SARMAP set at Low Uncertainty

As can be observed from the above map, all the indicators would suggest the prime search area is inside Poverty Bay. When asked to generate the maps for Low, Medium and High Uncertainty, the following was identified:

Where the SARMAP Application is utilised for drift modelling for a maritime SAROP, the outcomes should be peer reviewed, and a safety factor considered i.e. if the uncertainty rating is set to Low and no result is achieved in that area, then the modelling should be reset to Medium to consider a wider possible search area.

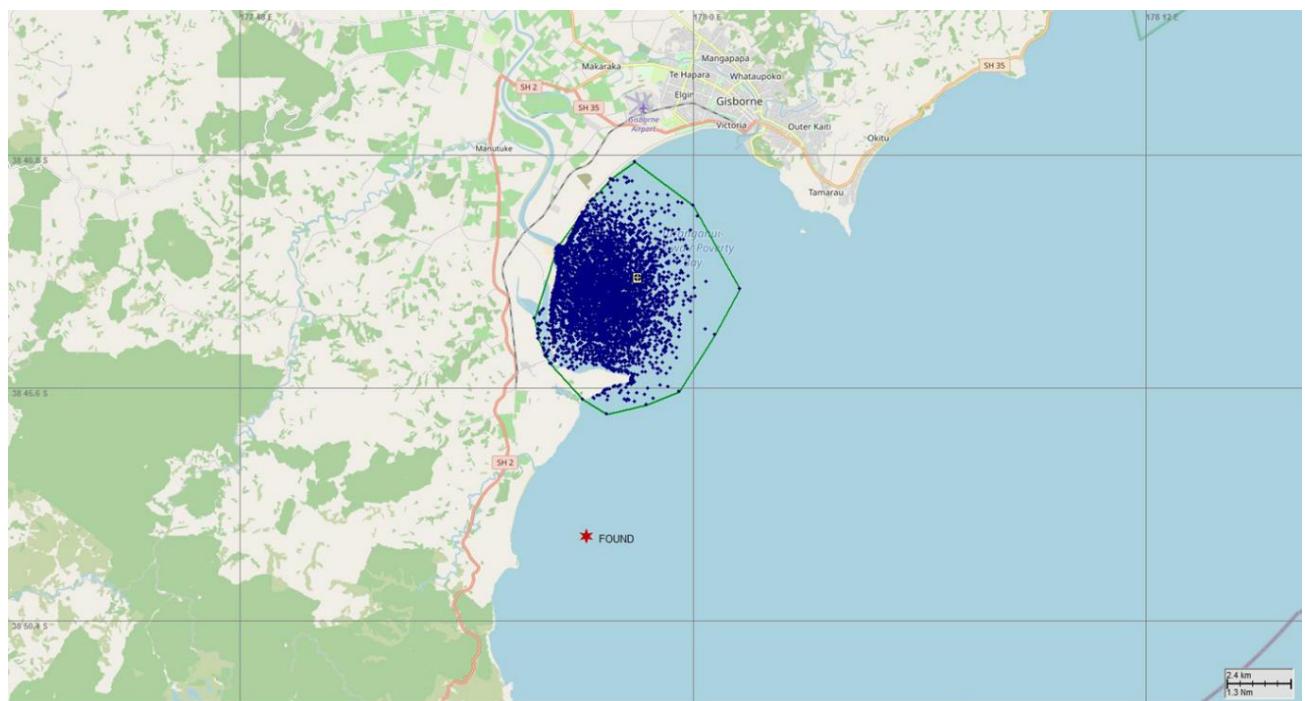
SAR Area at 5.30 pm on 2 November 2021

Low Uncertainty— Survivor located at 16:47 02 Nov 21 NZDT
(Monte Carlo Method)

As can be observed from the above maps, as the level of uncertainty increases from Low to High, so does the search area, primarily to the south towards Mahia peninsula. The default setting for SARMAP is *Medium*, enabling a wider search area determination to be identified.

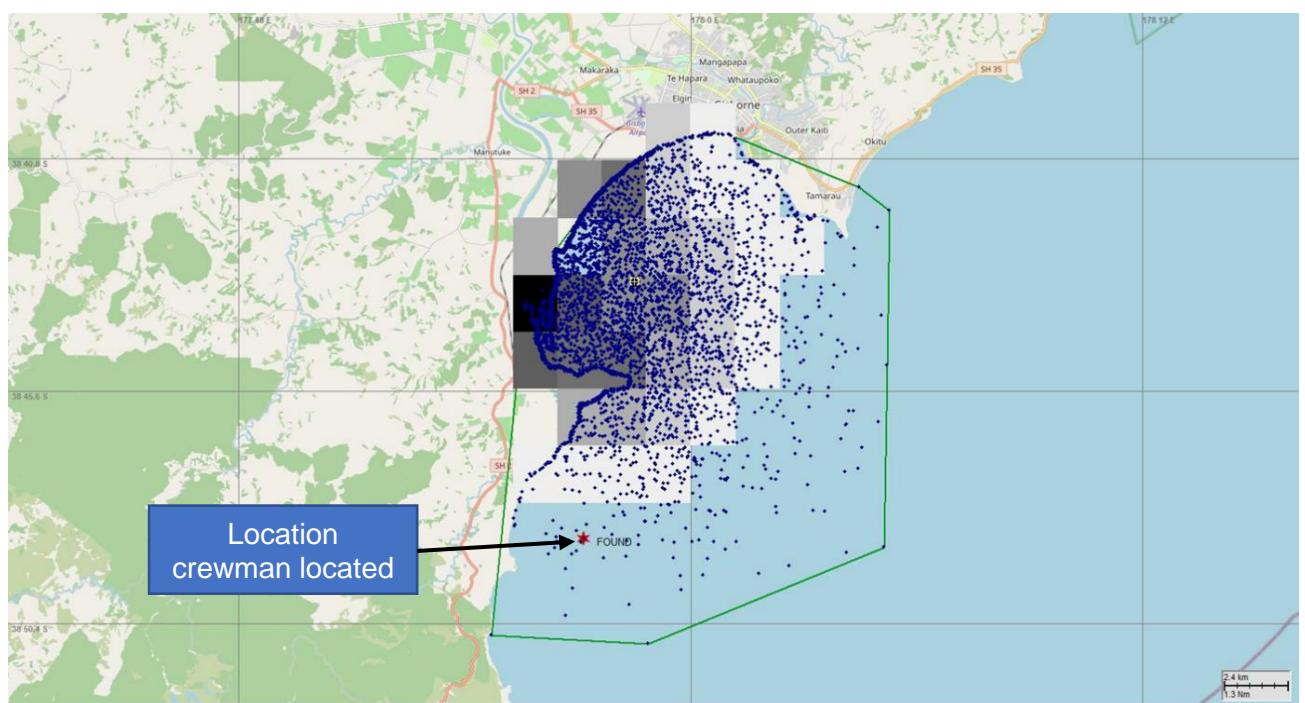
SAR Area at 5.30 pm on 2 November 2021

Medium Uncertainty— Survivor located at 16:47 02 Nov 21 NZDT
(Monte Carlo Method)

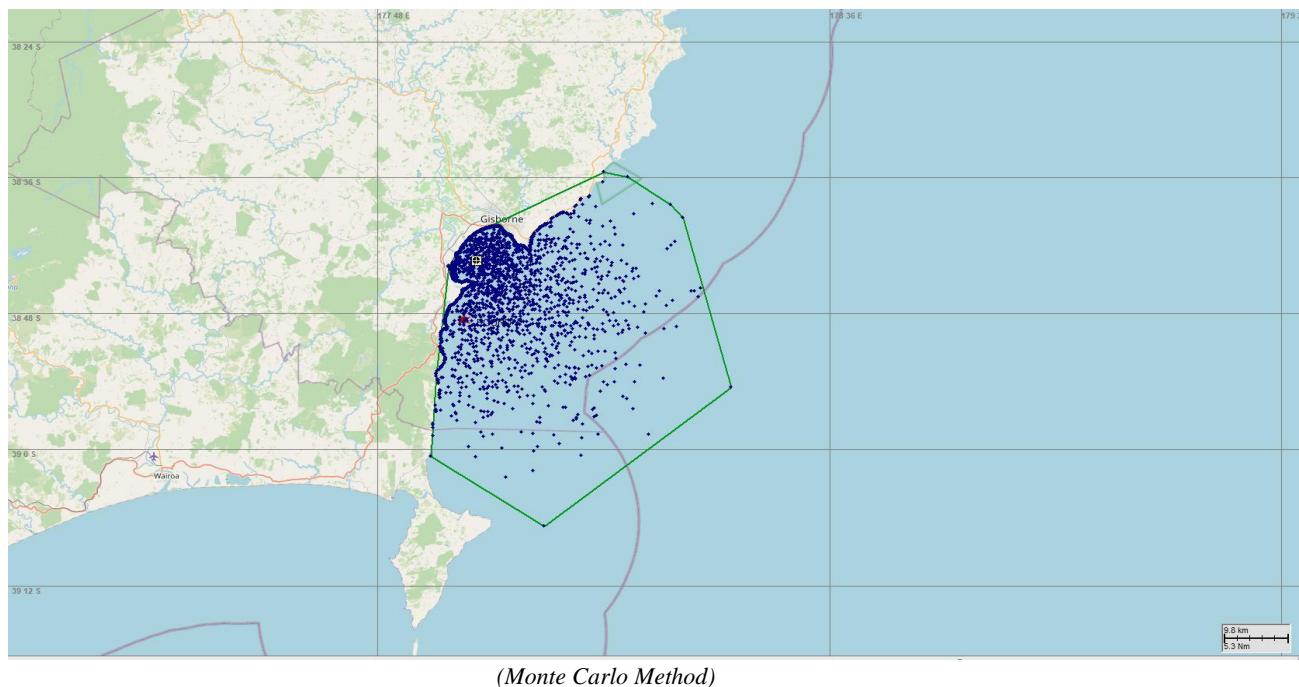
SAR Area at 5.30 pm on 2 November 2021

High Uncertainty – Survivor located at 16:47 02 Nov 21 NZDT

(Monte Carlo Method)
