# Report of the Independent Review into the Search and Rescue Operations for sv *Nina*

**Report of the Independent Review  
into the  
Search and Rescue Operations  
undertaken by  
Rescue Coordination Centre  
New Zealand  
June 2013 to January 2014**

Commissioned by Maritime New Zealand  
Carried out by David Baird  
June 2014

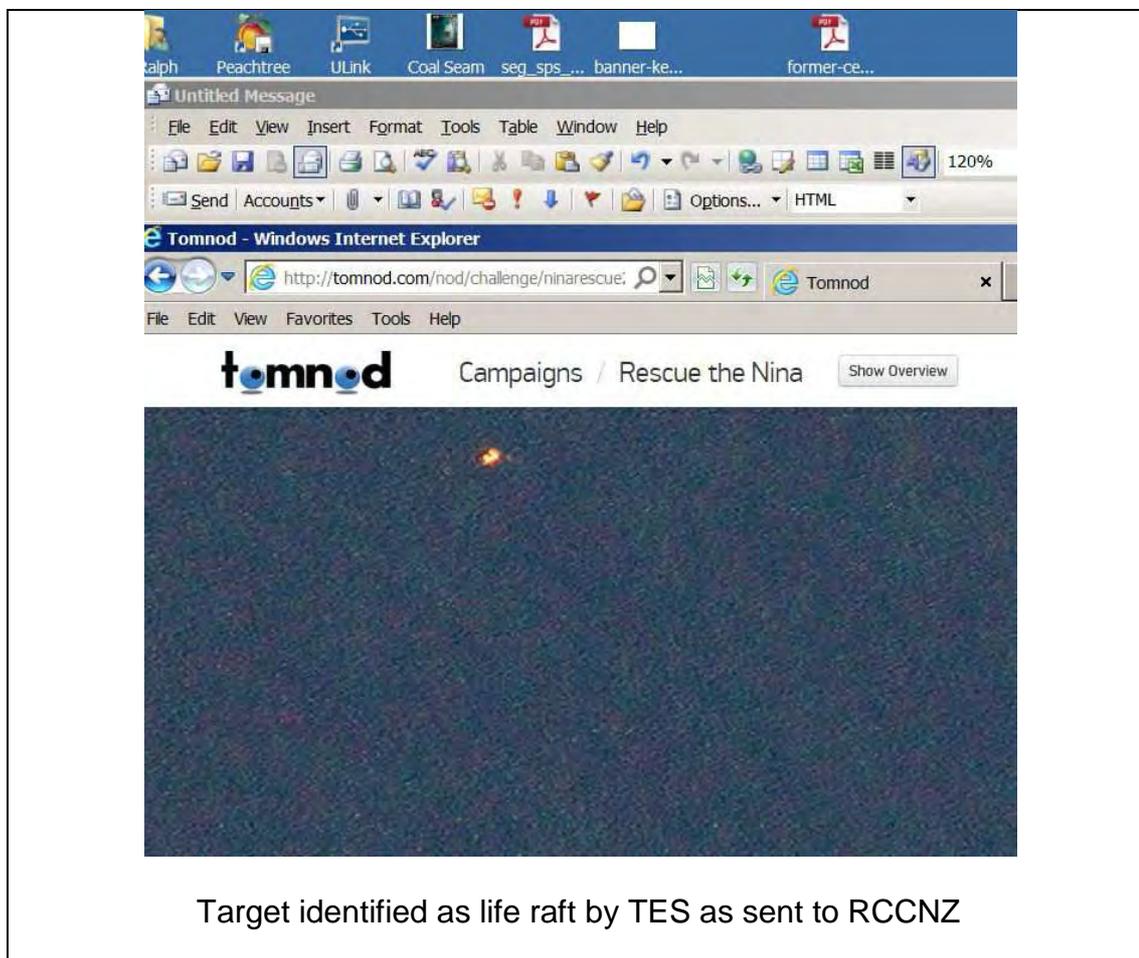
Target identified as life raft by TES as sent to RCCNZ

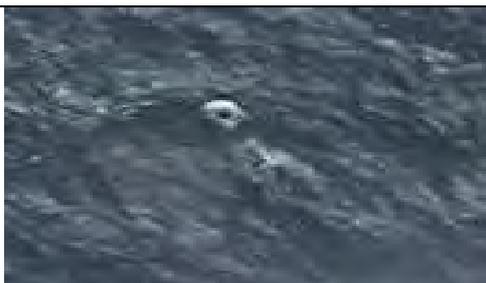
2<sup>nd</sup> September satellite picture of life raft supplied to RCCNZ by TES

The next day 10<sup>th</sup> September RCCNZ John Seward provides TES with drift modelling and Search Area Determination for the life raft picture location:

*Attached is the SARMAP model you requested. I have left the probability grid in the report so that you can decide which part or parts to focus on in the search area computed by the software (the overall area is nearly 8,500 square nautical miles).*

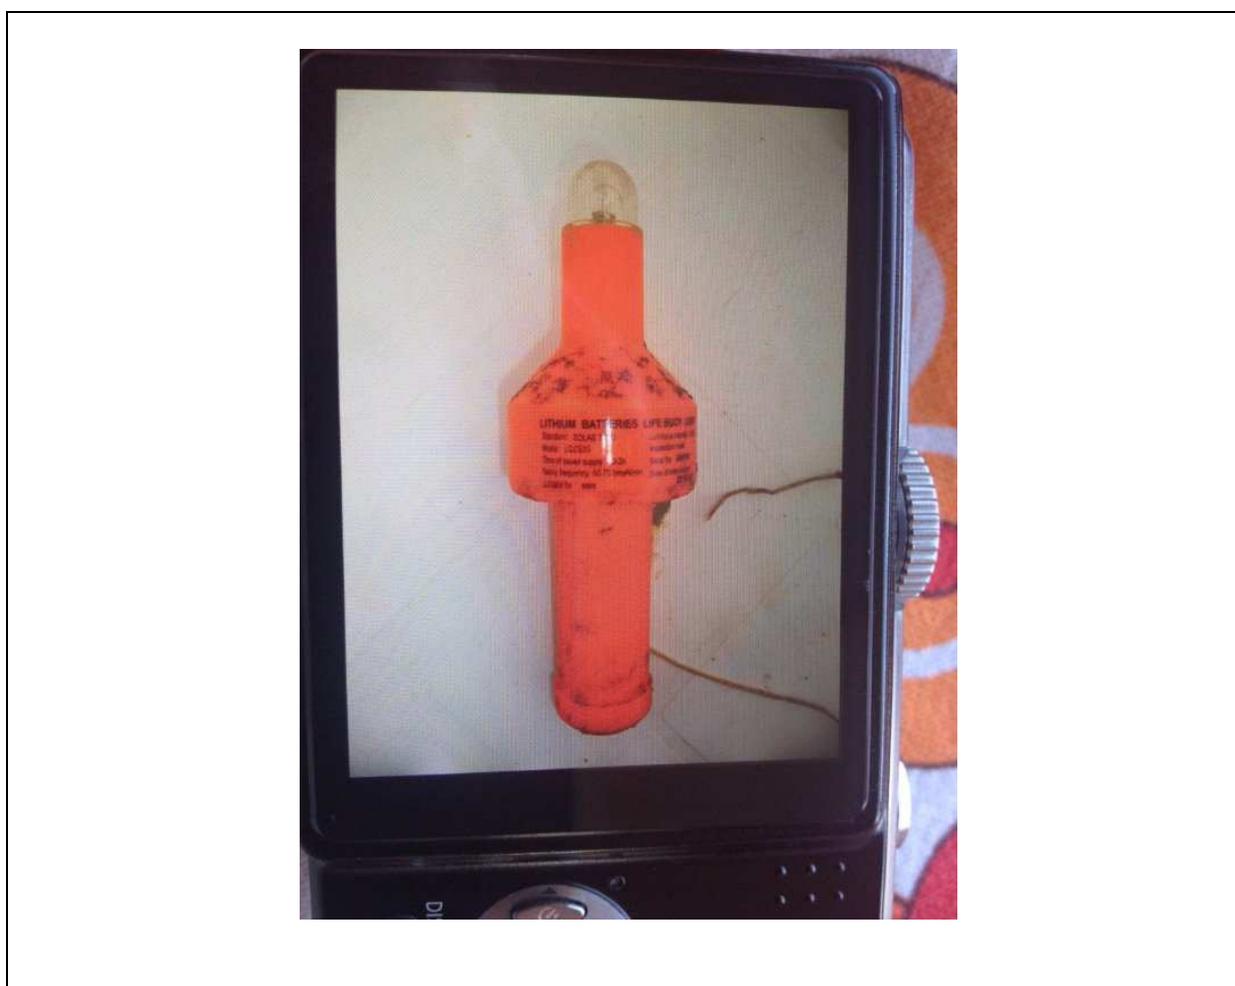
On 13<sup>th</sup> January 2014 TES's Ralph Baird contacted RCCNZ with a picture of a life buoy beacon and requested that RCCNZ consider this new information:

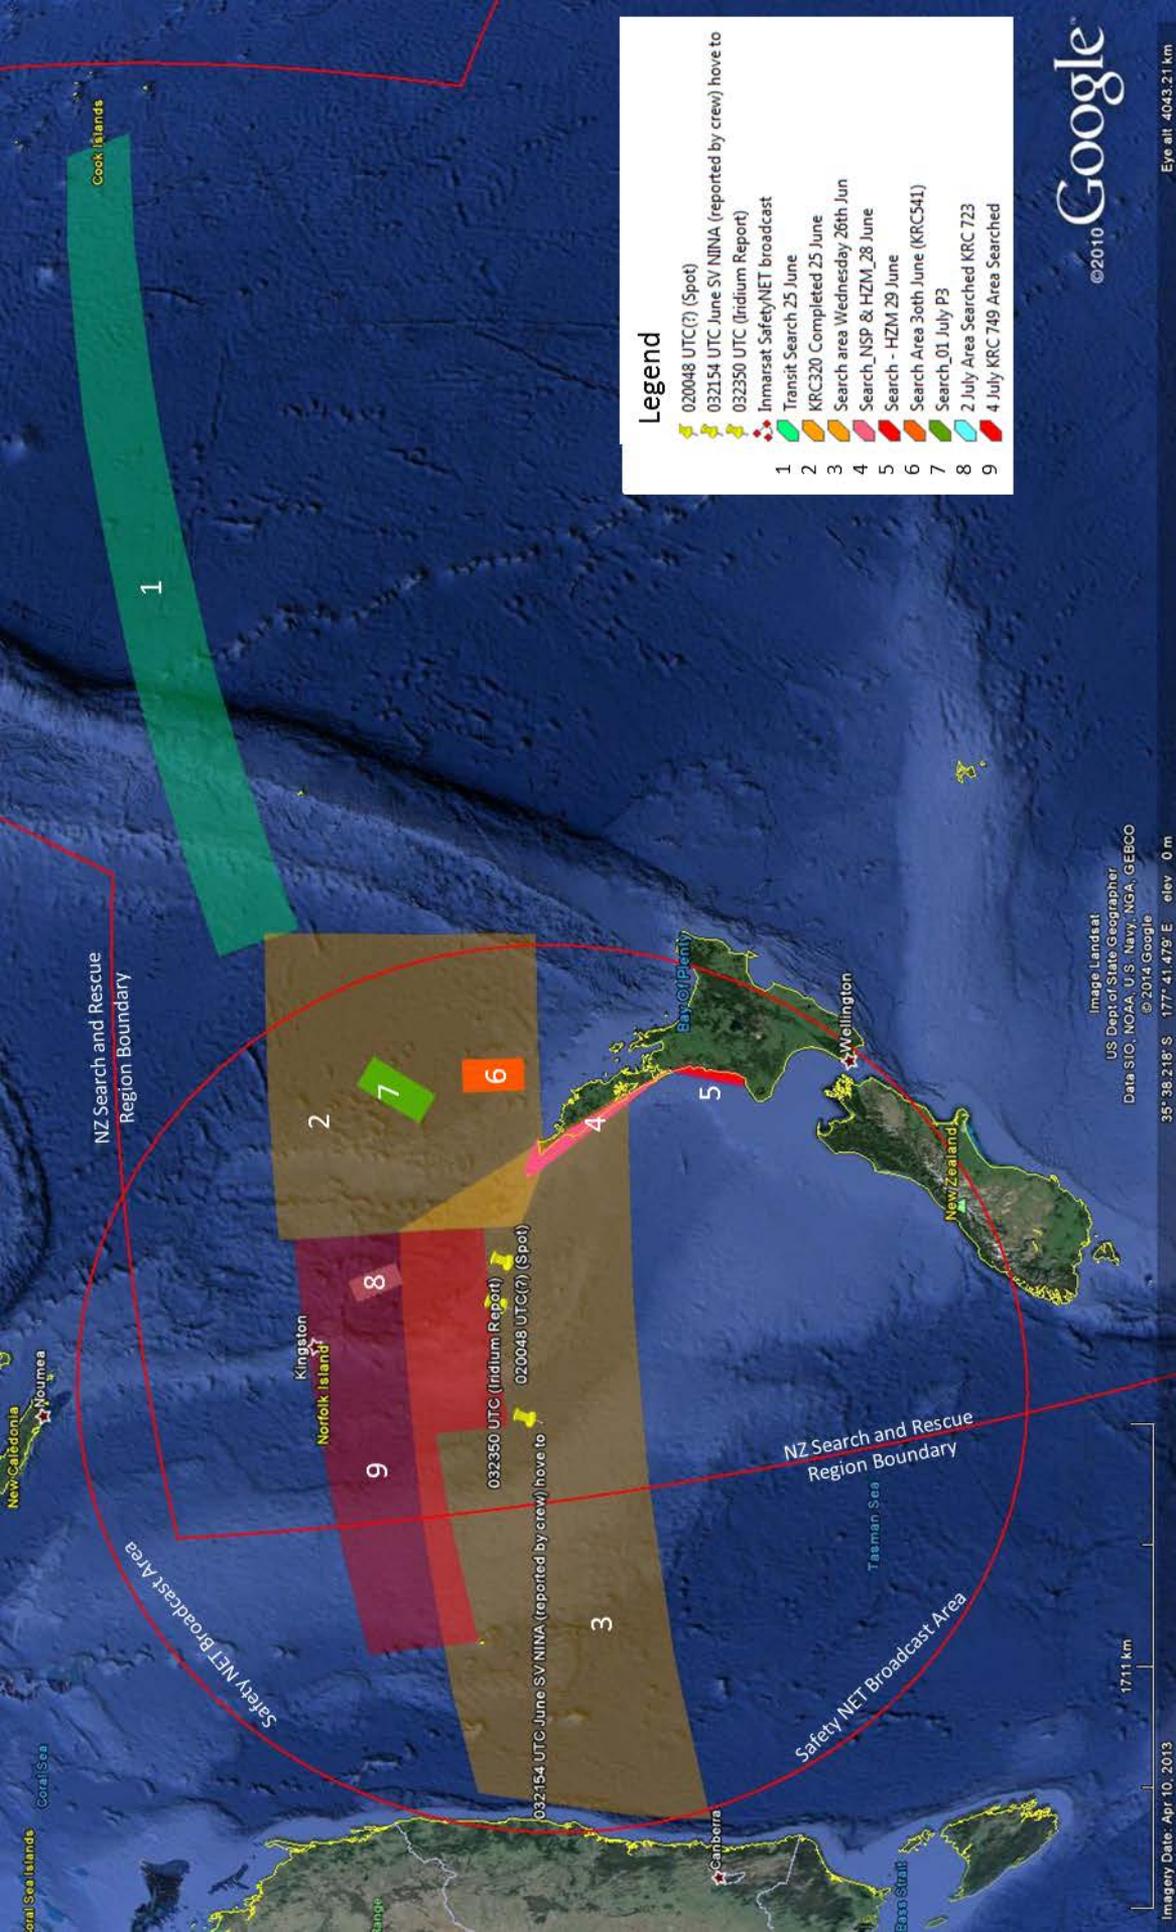
- 1 020048 UTC(?) (Spot)
- 2 032154 UTC June SV NINA (reported by crew) hove to
- 3 032350 UTC (Iridium Report)
- 4 Inmarsat SafetyNET broadcast
- 5 Transit Search 25 June
- 6 KRC320 Completed 25 June
- 7 Search area Wednesday 26th Jun
- 8 Search\_NSP & HZM\_28 June
- 9 Search - HZM 29 June
- 1 Search Area 30th June (KRC541)
- 2 Search\_01 July P3
- 3 2 July Area Searched KRC 723
- 4 4 July KRC 749 Area Searched

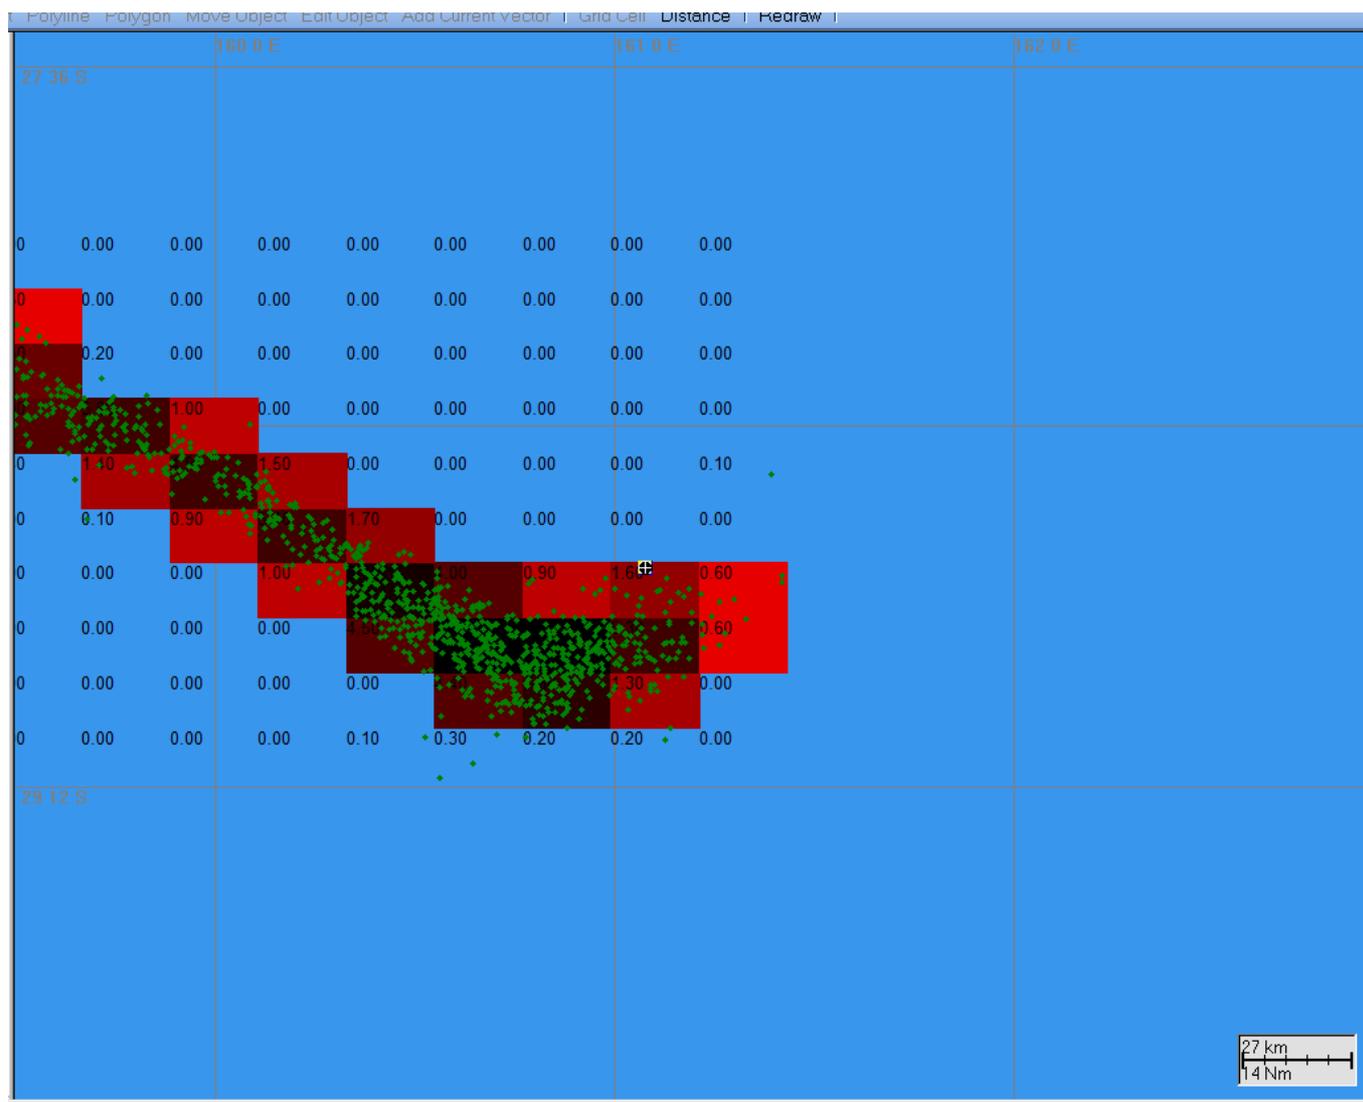
Incident	RCC0401_13_OM_20130909_LR
Description	LIFERAFT - 8 person with ballast
Drift Start Time	2/09/2013 23:52:00
Grid File	NZSRR.SHP
Current File	RCC0401_13_RD_LR_HYCOM_GLOBAL1.NC
Wind Driven Currents	Off
Wind File	RCC0401_13_OM_20130909_LR_GFS.NC

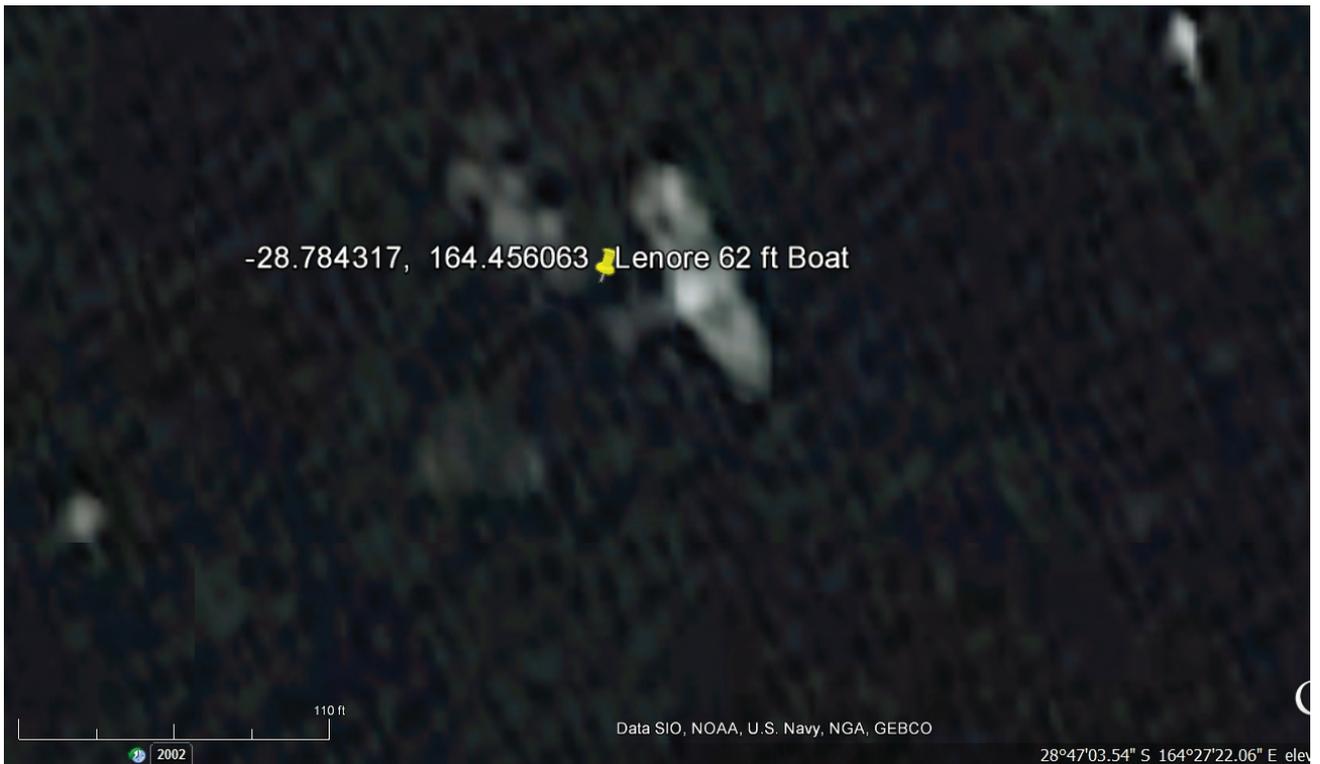
**Object C: Sailing vessel; imaged 15 Sep 2013  
28-47-03 S, 164-27-22 E**

RCCNZ decide to enlist NZ Defence specialists to analyse the satellite images being provided by TES. The specialists obtain original data from the satellite image providers. Advice provided to RCCNZ is that the objects in the satellite images are not the yacht *Nina*.

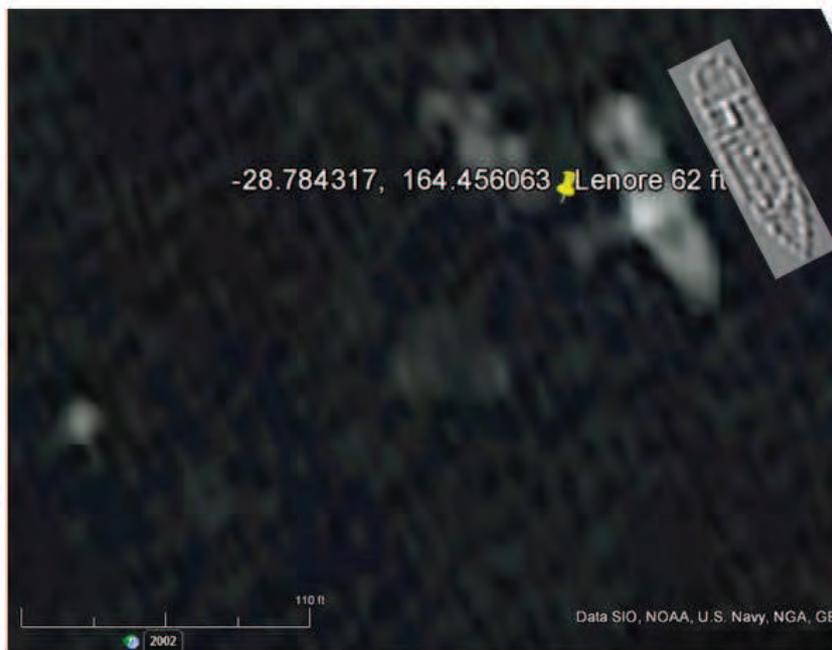
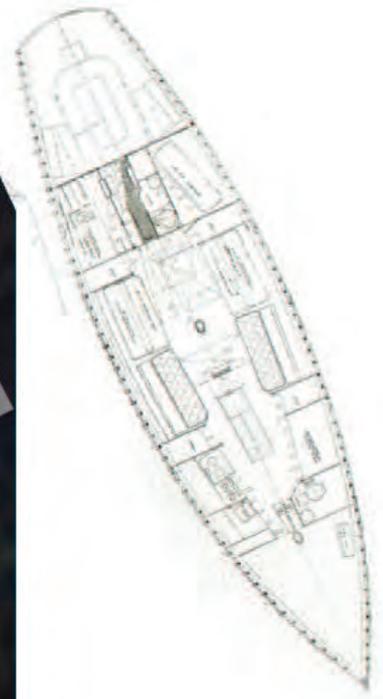
**Object C: Sailing vessel; imaged 15 Sep 2013; comparison to actual engineering drawing of the schooner Nina  
28-47-03 S, 164-27-22 E**

More satellite images are sent to RCCNZ that TES claim to be the *Nina*. One is overlaid with a schematic of the *Nina*:

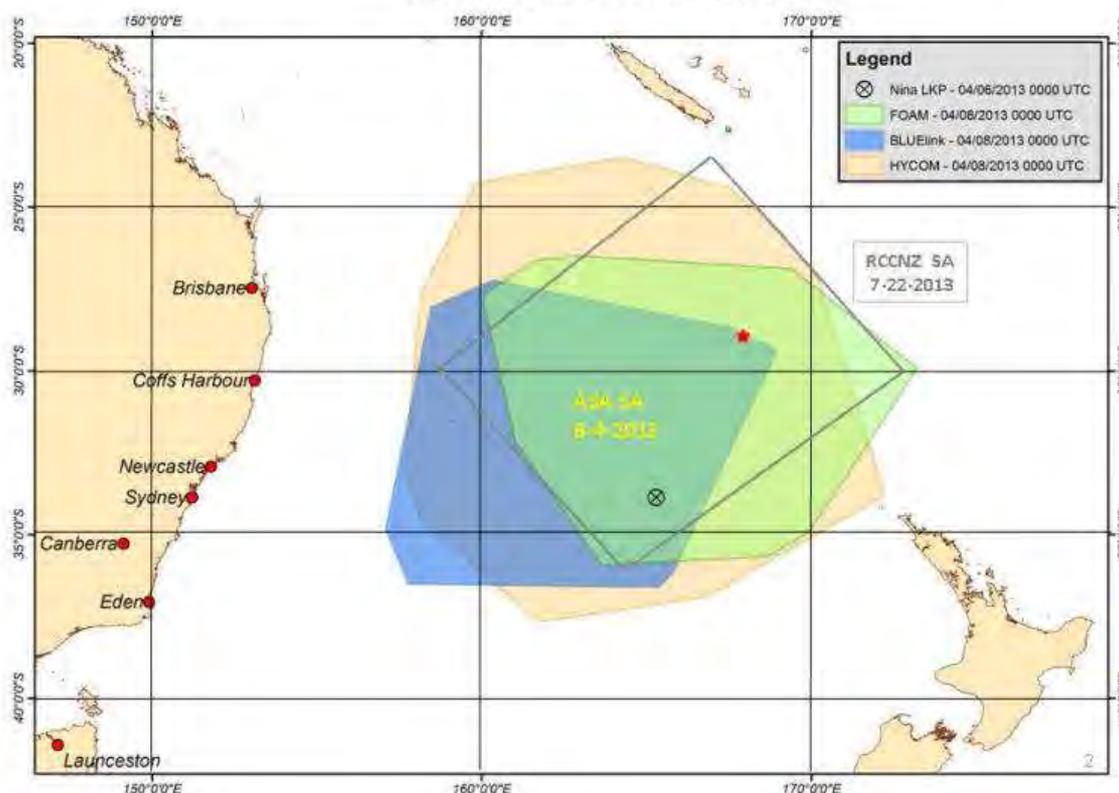
**ASA Predicted Search Areas for Aug 4, 2013 00:00:00 GMT  
Based on three sea current models**
