ZK-HTF
SEARCH AND RESCUE
OPERATION
INDEPENDENT REVIEW

Commissioned by the New Zealand
Search and Rescue Council

Written by Paul Fitzharris
28 April 2006

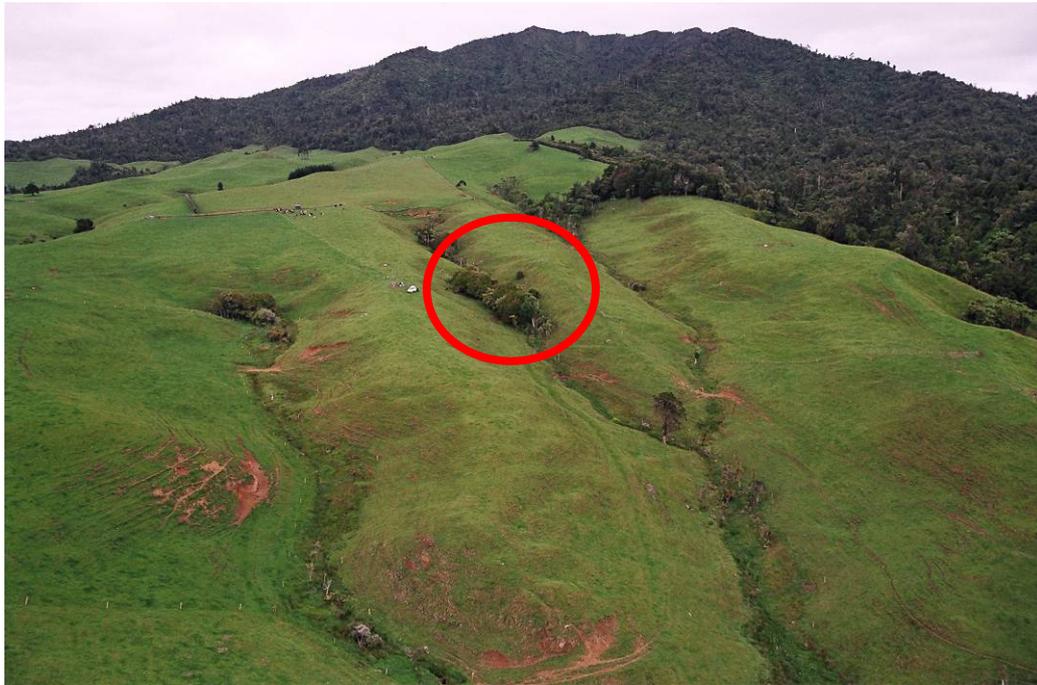
Figure 1 Location of ZK-HTF

57. The actual bush was only 120 metres long and 13 metres wide. The rotor span of ZK-HTF was 10 metres. If ZK-HTF had landed a metre either way it is likely its protrusion would have been very noticeable. The photographs in Figures 1 and 2 depict the site (circled) and visually display this. I have been informed that the area suffers from poor radar contact.

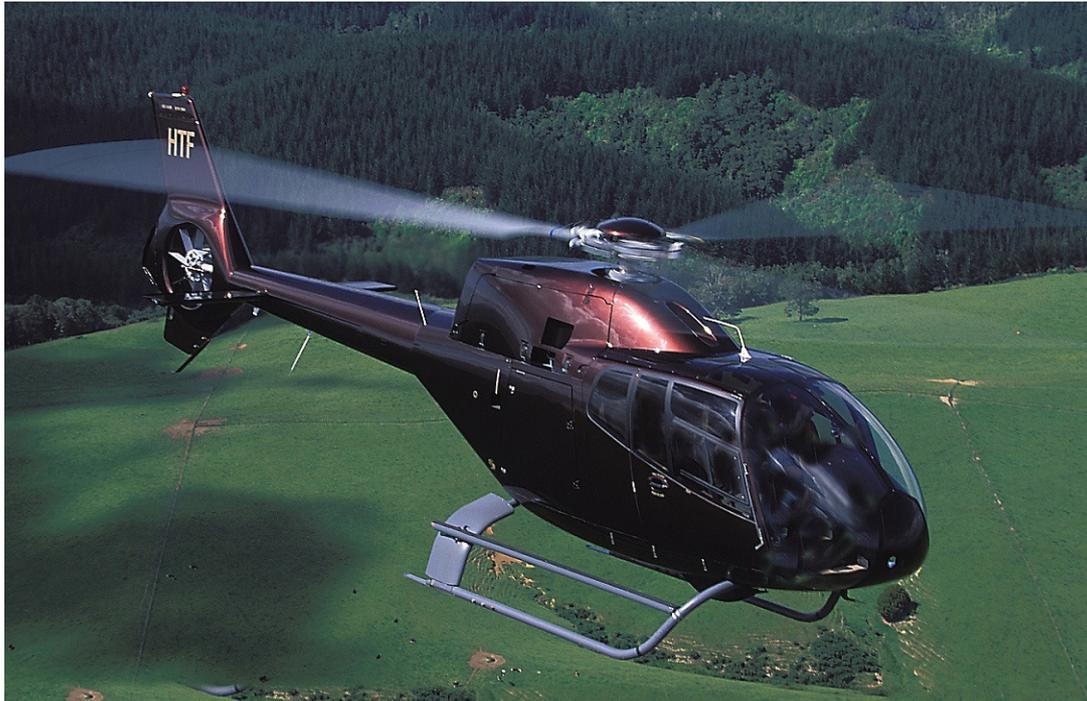
Figure 4. ZK-HTF Photographed on a pre delivery test flight, 20 November 2004

120. The helicopter involved in this incident was a late model Europter EC 120 B (a photograph of which appears in figure 4 below) It was fitted with a Kannad 406 AF-H Beacon ID C0064931FA58761. It is considered to be amongst the most advanced of its type for this aircraft.

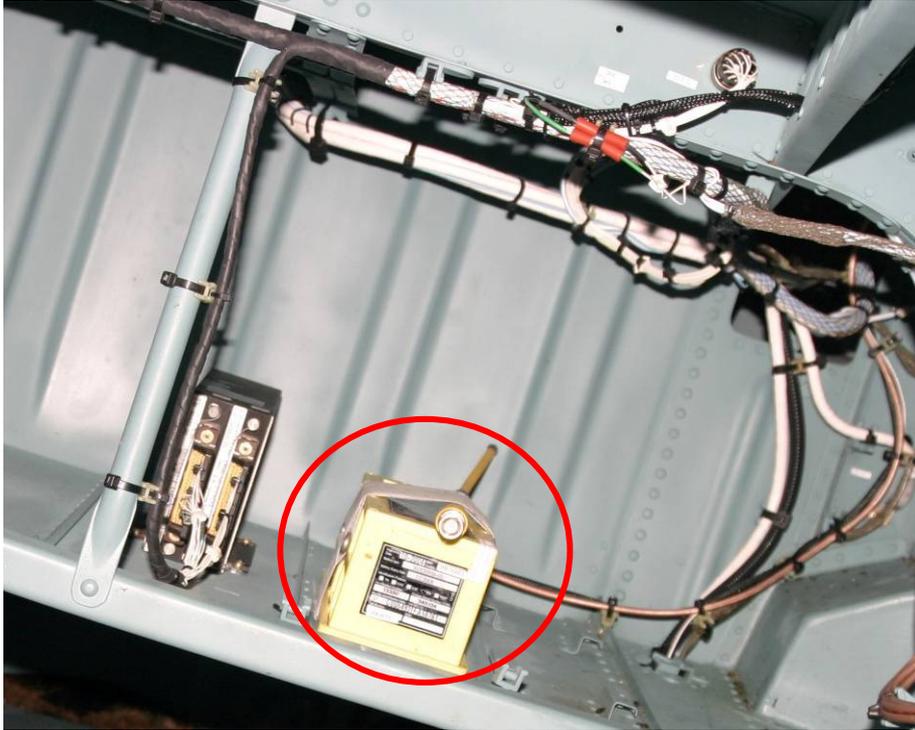
Figure 5. ELT within ZK-HTF

125. ZK-HTF was fitted with the new type of ELT, and Michael Erceg's family being aware of this, expected that in case of an emergency the helicopter could be traced rapidly. In this case the ELT was contained within the fuselage of the helicopter and required an external antenna. It is apparent that the antenna upon impact snapped off its base severely degrading the quality of the signal that it may have emitted. (See figures 5 and 6 below)

127. The CAA Safety Investigator arranged a test to establish if the ELT was functioning following the crash. EMC Technologies (NZ) Limited of Auckland carried out radiation emission tests. Their report is attached as Appendix 9. In summary the tests showed that the ELT functioned normally when an antenna was attached, but with the antenna broken as occurred in this crash the signal was seriously degraded.

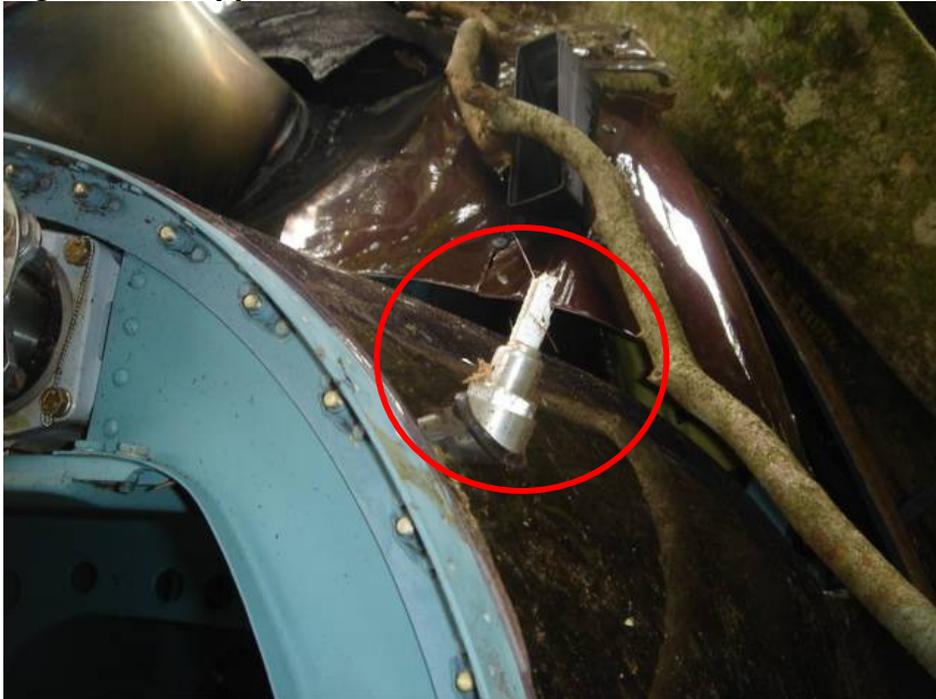
Figure 6. Snapped ELT External Aerial on ZK-HTF

128. With the CAA investigator it was intended to test the amount of signal emanating from the ELT with its broken antenna from the crash site. Time has precluded this test occurring. However the considered opinion of experts is that very little, if any, signal would have been detected even at close range.

139. The CAA continues to look to minimise the probability of damage to the transmitter and the antenna and their becoming separated in a crash. To this effect they have mandated that the ELT installation be such that:

- a. *'The location of the transmitter and antenna will minimise the potential for damage in accidents by impact or fire;*
- b. *The transmitter and external antenna (if used) are mounted as close to each other as possible;*
- c. *The attachment of the transmitter and external antenna (if used) to the airframe can support a 100g load applied through their respective centres of gravity in the plus and minus directions of the three principal axes of the aircraft;*
- d. *The coaxial cable between transmitter and antenna has vibration proof RF connectors on each end and when installed is secured to the aircraft structure leaving some slack at each end.'*
